# Boiler Failure Mechanisms

*By Douglas DeWitt-Dick, Stephen McIntyre, and Joseph Hofilena  
Ashland Specialty Chemical Company*

*This paper was presented as part of the 61st Annual International Water Conference™, which took place in Pittsburgh, PA (USA), October 22-26, 2002.*

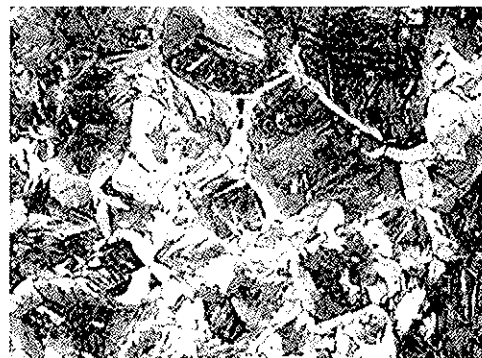
Virtually all types of tubes, which carry water or steam and are exposed to high operating temperatures are susceptible to this type of failure. The more violent ruptures occur at tube metal operating temperatures well above the ASME oxidation limits of the material and typically above the eutectoid transformation temperature of 1340°F (727°C). Peak metal operating temperatures above the eutectoid can be estimated by the amount of bainite or martensite mixed with ferrite in the metal microstructure at the failure origin as shown in Figure 2.

Fig. 2 - Microstructure of Overheating Failure.

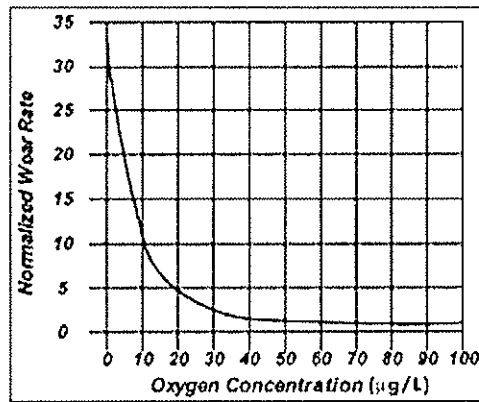
Dissolved oxygen (DO) concentration has a direct impact of the potential for flow assisted corrosion. Above a DO concentration of 30 mg/L (ppb), the normalized wear rate on carbon steel is at a minimum. Below 30 mg/L (ppb) DO, the normalized wear rate on carbon steel increases exponentially, as depicted in Figure 20.

Fig. 20 - Effect of Dissolved Oxygen on FAC.

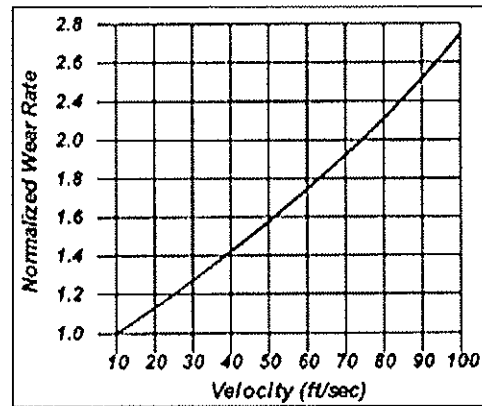
Fig. 21 - Effect of Velocity on FAC.

It only stands to reason that the mass velocity will have a significant influence on flow-assisted corrosion. Below 10 ft/sec (3.05 M/sec), the normalized wear rate is minimal, increasing 2.8 times at 100 ft/sec (30.5 M/sec). Figure 21 and Figure 22 illustrate the effect of velocity on normalized wear rate.

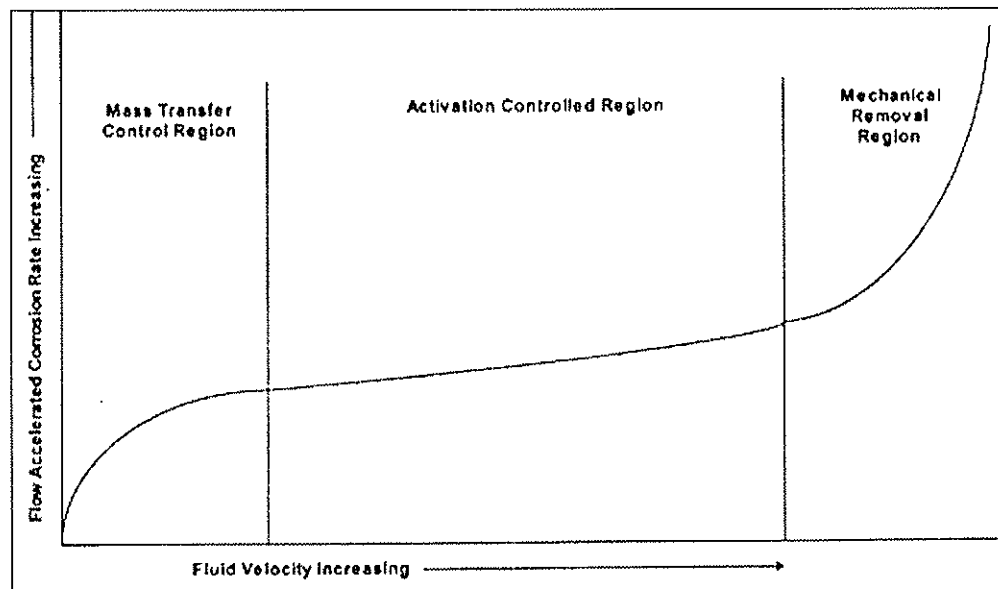
Fig. 22 - Effect of Velocity on FAC.
