## Taming Condenser Tube Leaks: Common Condenser Tube Failure Mechanisms

By David G. Daniels  
Mechanical & Materials Engineering

## Taming Condenser Tube Leaks: Commons Condenser Tube Failure Mechanisms

From the AWT ANALYST - FALL 2012

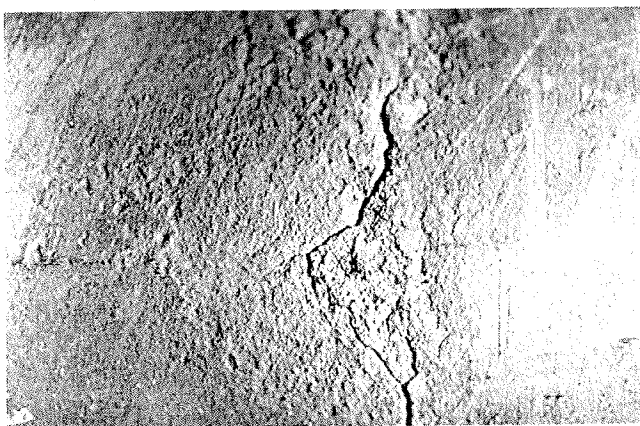
**Figure 5: Admiralty attacked; Excess ammonia in the cooling water can also cause stress corrosion cracking of admiralty brass tubing.**

Carbon dioxide also lowers the pH of the condensate, requiring additional ammonia feed to maintain the desired pH in the feedwater, producing higher ammonia levels in the condensate. High levels of ammonia can also cause stress corrosion cracking in admiralty brass (Figure 5).

Susceptibility to ammonia grooving and ammonia-induced stress corrosion cracking drops dramatically as the amount of nickel in the alloy increases. Even a 90:10 Cu-Ni alloy provides far more protection against these forms of corrosion.
